**GROUT
SCOUTS™**

Grout Scouts, Inc. uses pressure grouting to repair reinforced concrete pipes (RCP); reinforced concrete box culverts (RCBC); scoured bridge abutments; and annulus grouting of Spiral Wound Liners. Since 1996, we have used Trenchless Technology for City, County, State, and Federal Agencies.

TURNING INFRASTRUCTURE LIABILITIES INTO CAPITAL ASSETS

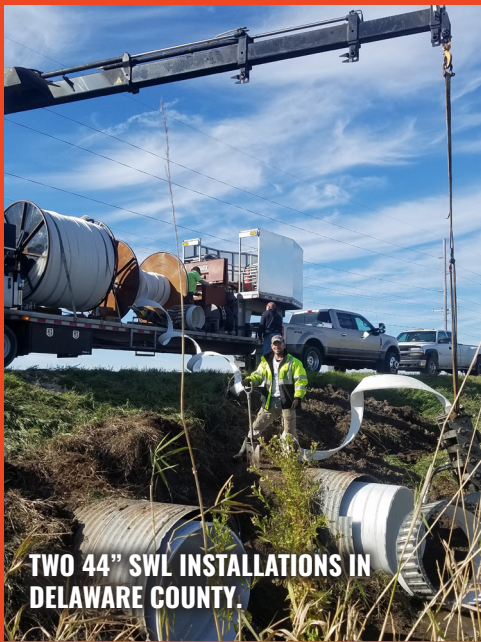
TWO 44" SWL INSTALLATIONS IN DELAWARE COUNTY.

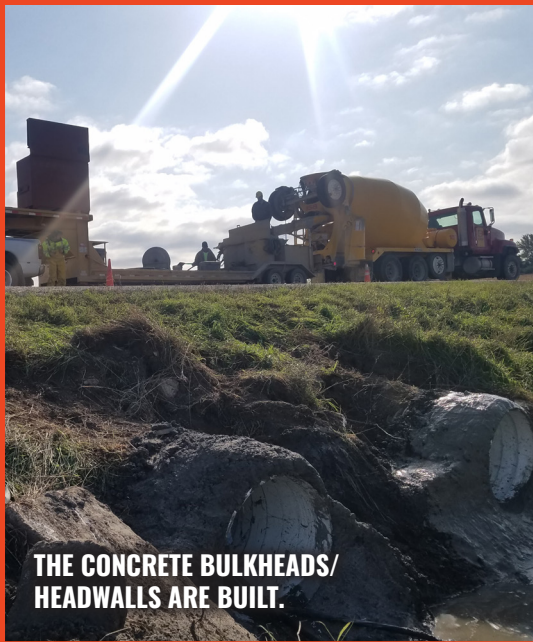
THE CONCRETE BULKHEADS/ HEADWALLS ARE BUILT.

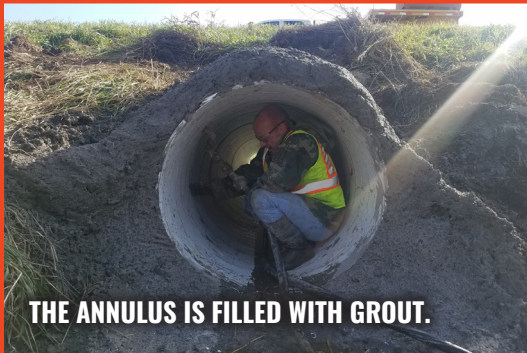
THE ANNULUS IS FILLED WITH GROUT.

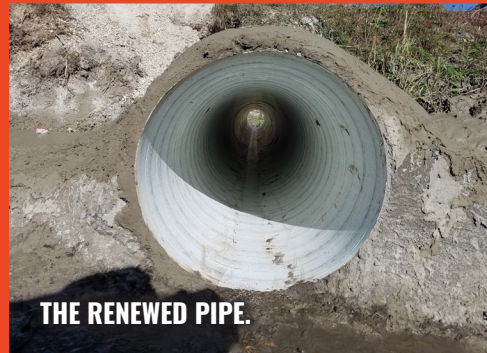
THE RENEWED PIPE.

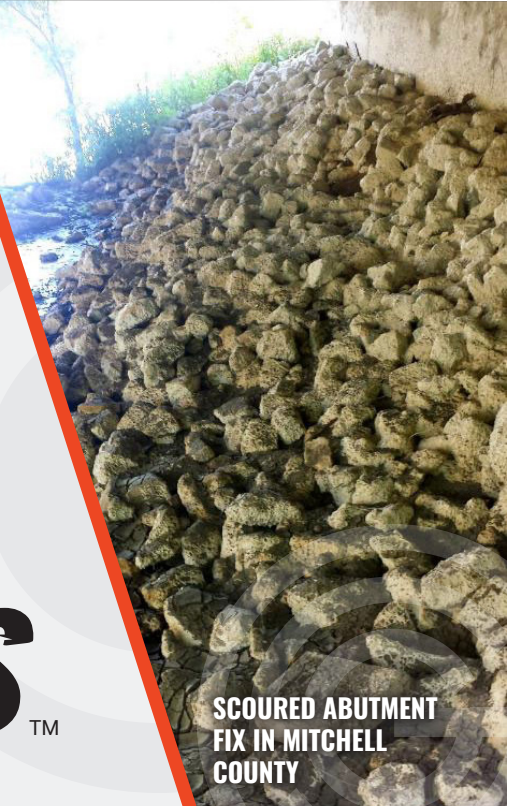
SCoured ABUTMENT
FIX IN MITCHELL
COUNTY

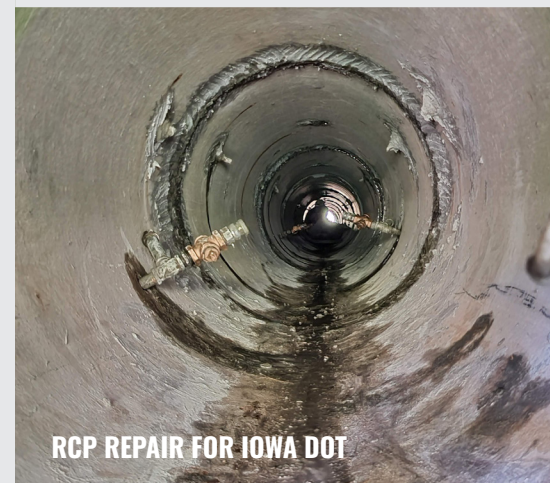
RCP REPAIR FOR IOWA DOT

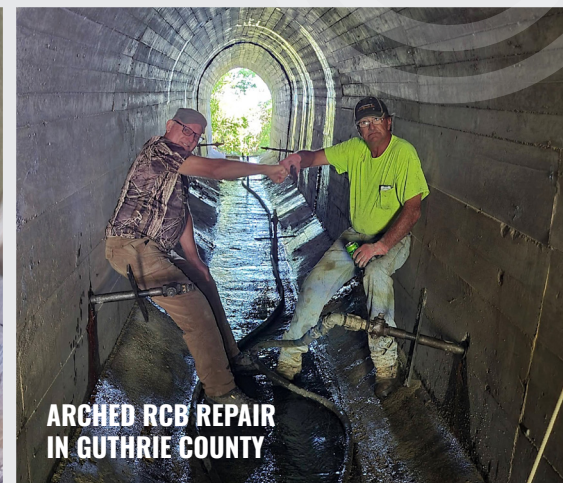
ARCHED RCB REPAIR
IN GUTHRIE COUNTY

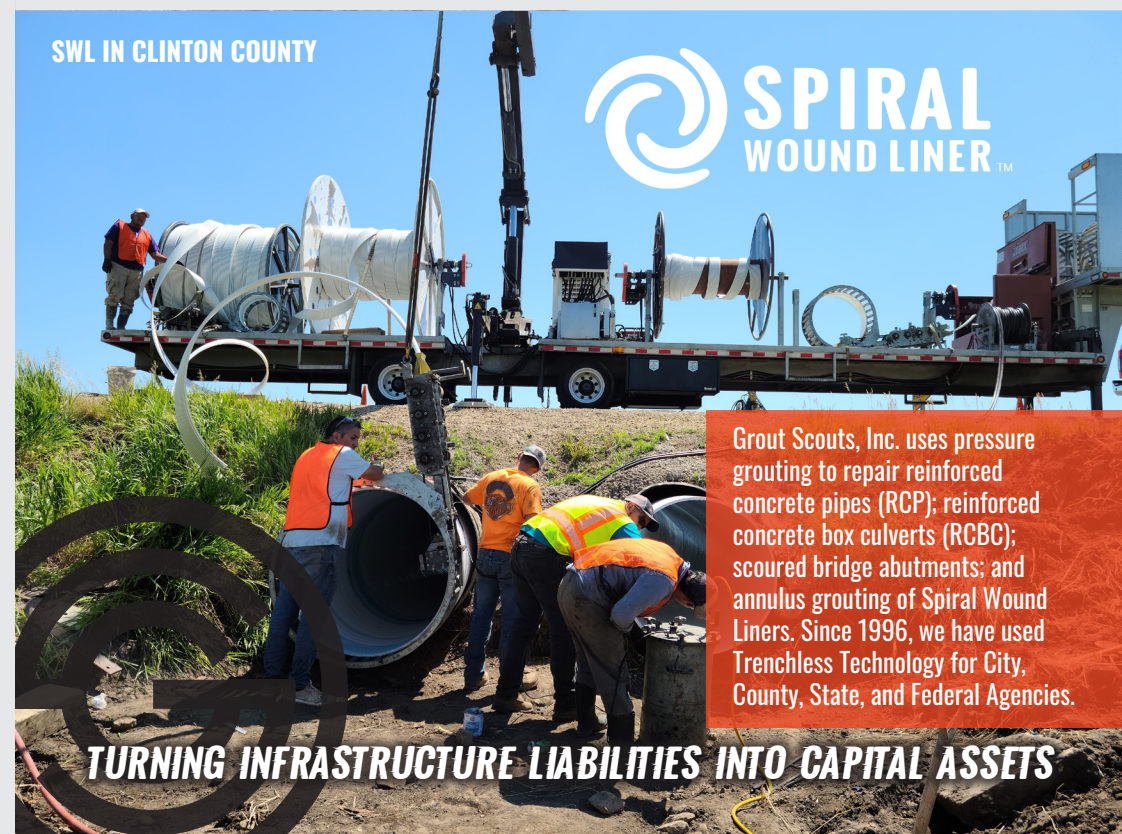
SWL IN CLINTON COUNTY

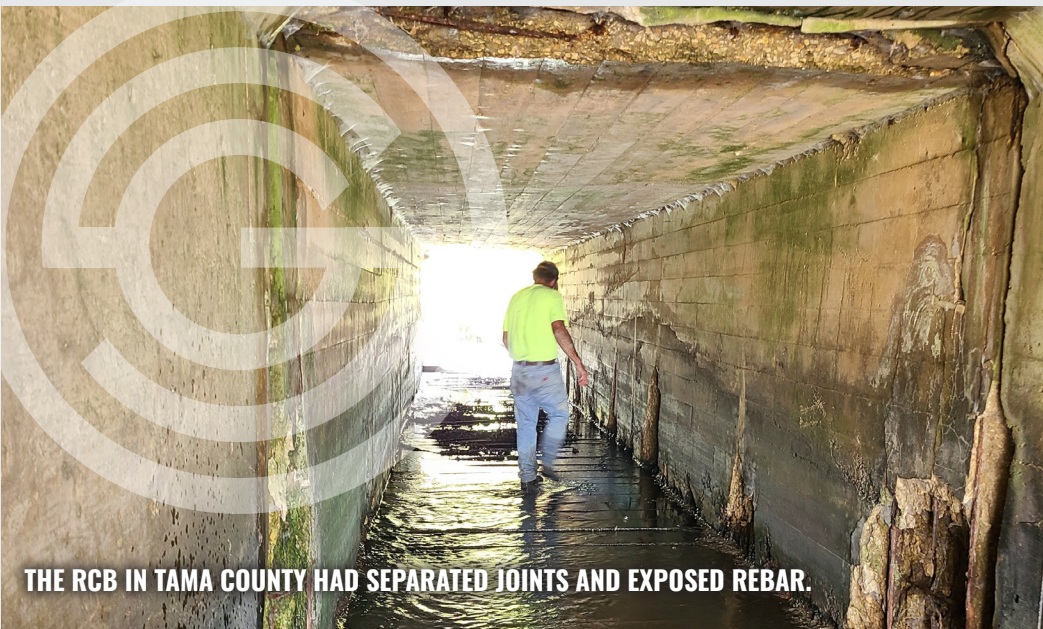
THE RCB IN TAMA COUNTY HAD SEPARATED JOINTS AND EXPOSED REBAR.

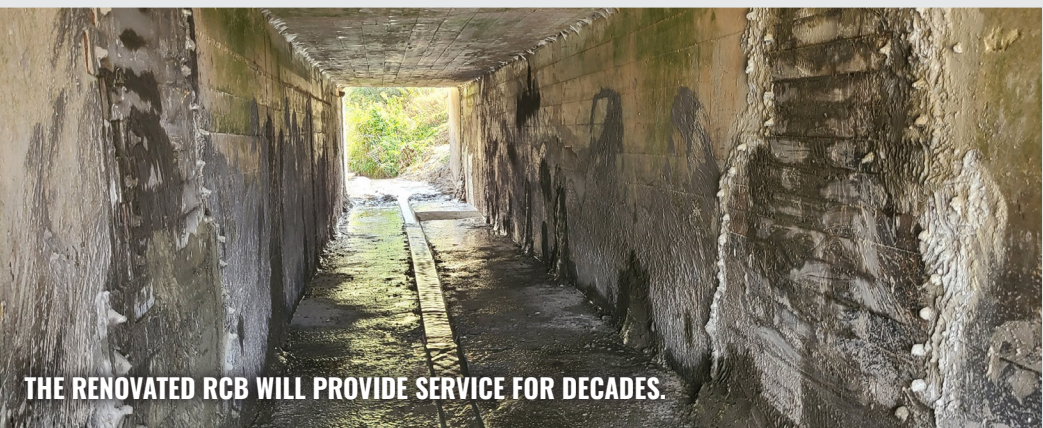
THE RENOVATED RCB WILL PROVIDE SERVICE FOR DECADES.

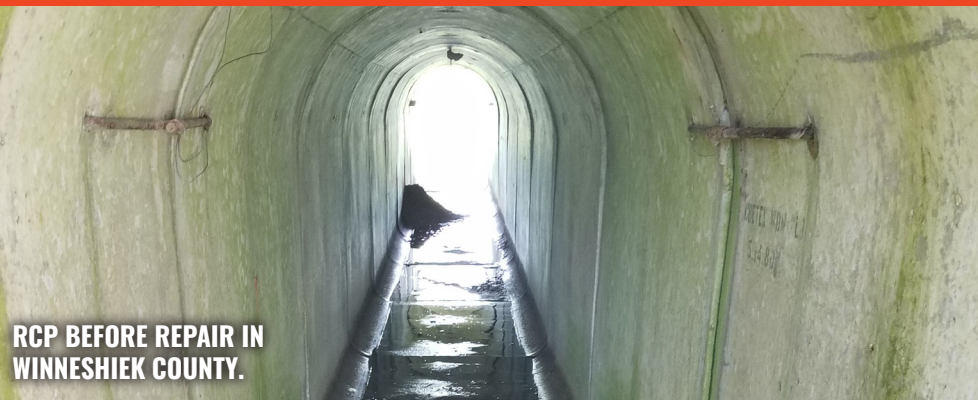
RCP BEFORE REPAIR IN WINNESHIEK COUNTY.

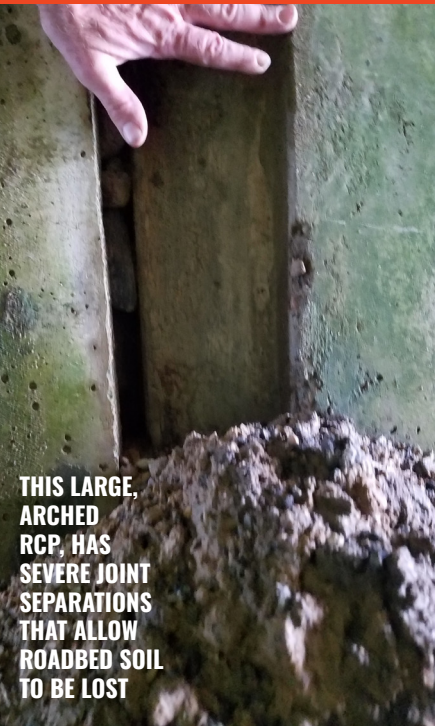
THIS LARGE, ARCHED RCP, HAS SEVERE JOINT SEPARATIONS THAT ALLOW ROADBED SOIL TO BE LOST

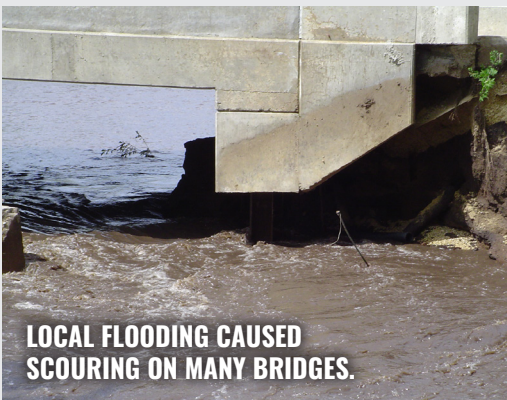
LOCAL FLOODING CAUSED SCOURING ON MANY BRIDGES.
